NASA Technical Memorandum 86024

In-Flight Load Testing of Advanced Shuttle Thermal Protection Systems

December 1983

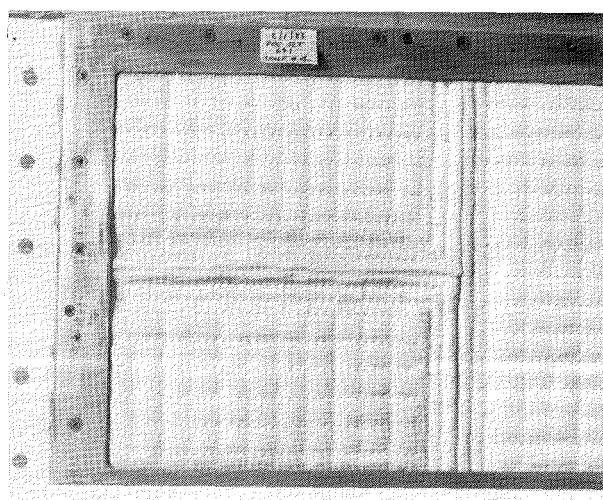
The baseline AFRSI test articles (configurations 3-5) contained loose or broken threads and areas of slight puckering, especially the butt-jointed configurations (configurations 3 and 4), which were noted during preflight inspections. An example of this is shown in Fig. 15. These conditions were not aggravated, however, even when the materials were tested at 40% above the design

airloads. The one exception (configuration 3) manifested itself as an increase in puckering at the joint running perpendicular to the flow. This increased puckering created a small step in the test article, but no thread damage. All the test articles were judged acceptable for further testing after postflight inspections.

Fig. 15 Example of loose and broken threads and puckering, typical of the baseline AFRSI test blankets.
